RESEARCH USING ATOMIC METHODS ON MATERIALS USED IN THE MANUFACTURE OF COMPONENTS FOR MEDICAL IMPLANTS

Abstract. *The materials used to manufacture prosthetic components must meet the conditions of biocompatibility imposed by the human body, to be mechanically resistant, to present a good resistance to corrosion, to be resistant to aging process and not to generate flows of attrition particles. This paper aims the selection and analysing of some biocompatible metallic materials (the austenitic stainless steel and titanium alloys). Thus, various prosthetic elements made by rapid prototyping (RP) technologies from Ti6Al4V alloys obtained using laser selective melting (SLS Technology) have a major advantage in the special geometric form for medicine, creating a personalized implant for each patient and with superior properties on the quality of the material used. Studies in recent years have led to the conclusion that the biocompatibility of an implant depends on many factors such as: the general health status of the patient, age, tissue permeability, immunological factors, but also the implant characteristics (roughness and porosity of the material, chemical composition, corrosion pr

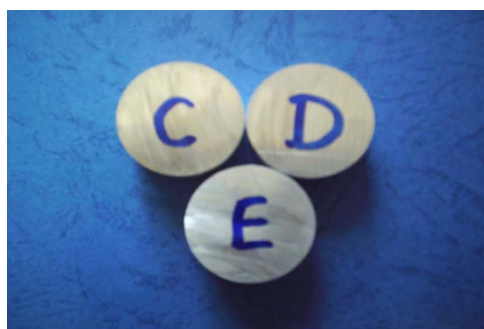
Figure 1a). The samples C, D, E.

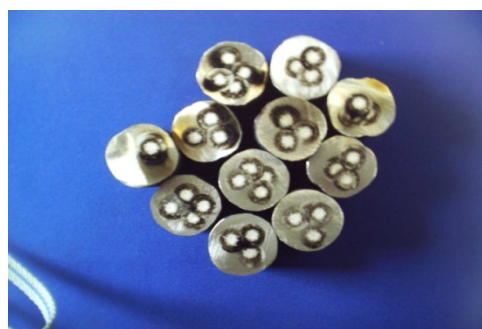
Figure 1b). The steel samples spectrochemically investigated.

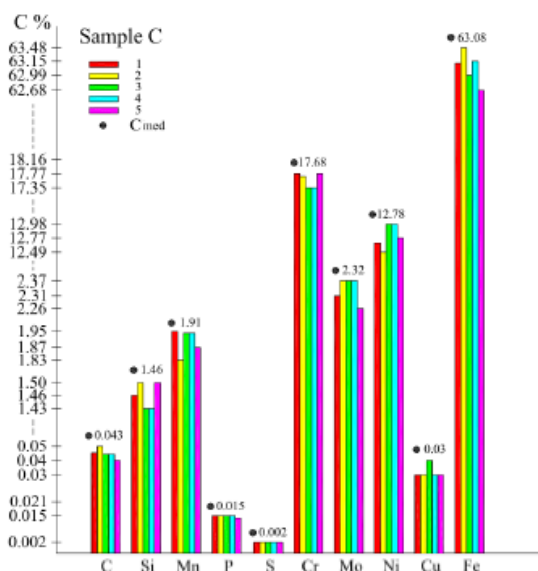
Figure 2. The concentration values and the average concentration associated with sample C.

The results of the spectral tests of samples are presented in additional data are given in Figs. 2 and 3, and Table 1. It was chosen one sample from the spectrochemically investigated 316 L steel samples who was investigated by metallographic optical microscopy and SEM-EDS microscopy (Scanning Electron Microscopy & Energy Dispersion Spectroscopy). This sample has 4 distinct sparks, which are representative of the sparking process.

The results of the 316L steel samples tested spectrochemically are presented into Figs. 2 and 3, and Table 1. Each sparking area of the 316L specimen tested spectrochemically was visually examined, after which images from the morphologically different areas were acquired. Thus, overall images will be presented. After analyzing the images acquired for each sparking area, the most representative images were selected, which are presented in the following.

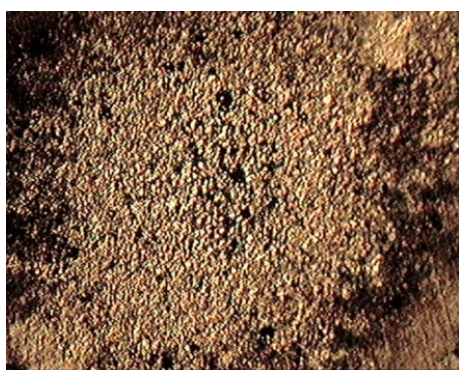
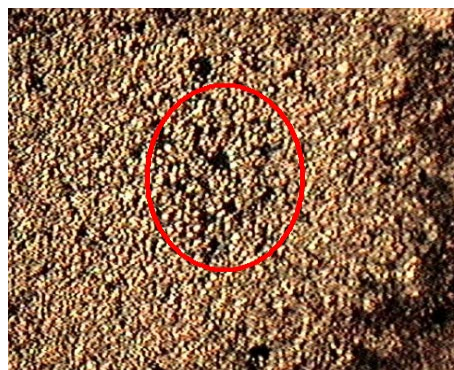
Figure 4.a) Overall image of the sparking area.

Figure 4.b) Detail.

In Figs. 5 and 6 (a, b) are presented the morphological aspects of a sparking surface at a scale of tenths of millimeters. Figure 4 shows a specific attack mode of the argon discharge channels, during specimen sparking for spectrochemical analysis, respectively a pitting attack in the center of the sparking zone. Thus, about 15 pores (excavations) can be counted in the circle with a radius of about 30% of the radius of the sparked area (Fig. 5). On the right side you can see the characteristic aspect of the border, with the crevices of attack, but with less incidence of pitting. The detail of the central area in Fig. 4 reveals the superficial morphology of the crevasses and Fig. 5 reveals the cylindrical morphology of the crevasses surrounding the central crevasse. On the other hand, Figs. 4-6 it is noticed that there is no local area that has not been bombarded / sparked. The justification would be that there are no traces of morphological aspects generated by sample preparation, as seen at the periphery of the whole picture. The image in Fig. 6 reveals the existence of concentrated attack zones at the periphery of the sparked area and the lack of an attacking, sparking "texture". The images of the peripheral areas of the sparked area reveal the scattering sparks and the existence of the crevices in a "fully attacked field", but with a lower intensity. Optical microscopy investigations revealed several new aspects for the spectral analysis of 316L steels, respectively: the sparked area is attacked relatively uniformly on 85-90% of the apparent spark gap diameter; at the periphery of the spark spot there is a sudden transition from the uniform attack regime to unattached areas; inclusions and other defects are preferential attack points of sparks and are the cause of the generation of pitting and crevices in the sparking area; it has been estimated that a spark (a discharge channel) "attacks" an area of about 300 mm^2 ; some general images suggest a non-homogeneous attack caused by the specific distribution of the sparking channels.

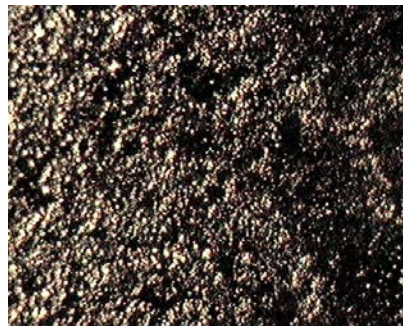
Figure 6. Morphological aspects of a sparking surface; marginal area of a sparking surface.

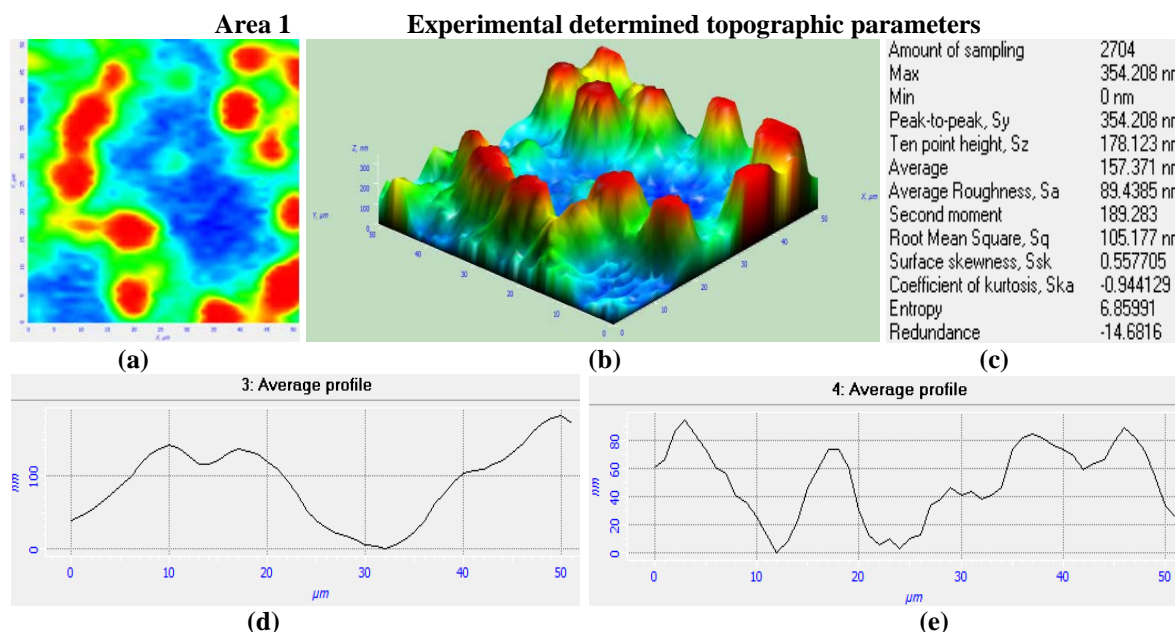
Figure 15. AFM analysis of surface area 1:

(a) 2D scanned surface, (b) converted to 3D scanned surface, (c) determine topographic parameters, (d) The average profile in the x direction, (e) The average profile in the y-direction.

In the images below (Figs.15-17) presents the results of the analysis, with AFM for selected areas. In all these images show that: the surface of the 2D scan of each zone (a), converted into 3D scanned surface (b) determined topographic parameters (c), the average profile in the x direction (d) and the average profile in the y direction (e).

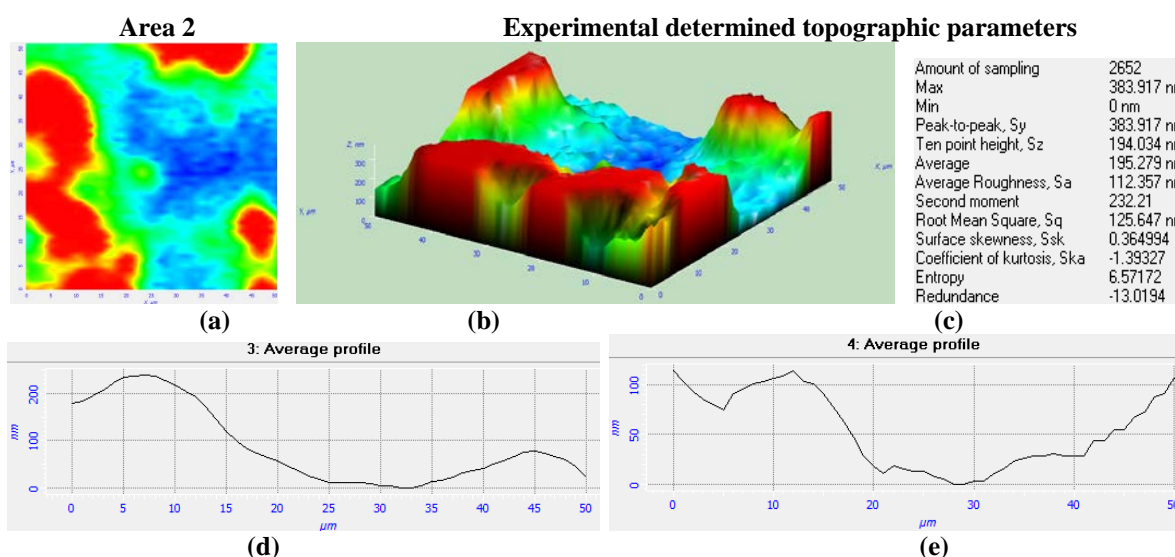
Figure 16. AFM analysis of surface area 2:

(A) 2D scanned surface, (b) converted to 3D scanned surface, (c) determine topographic parameters, (d) The average profile in the x direction, (e) The average profile in the y-direction.
